Manhole Inspection Summary

Manhole # S07CC1010MH

Insp Date: **6/28/07 3:45 PM**

Location Address: **3801 SEQUOIA AVE**

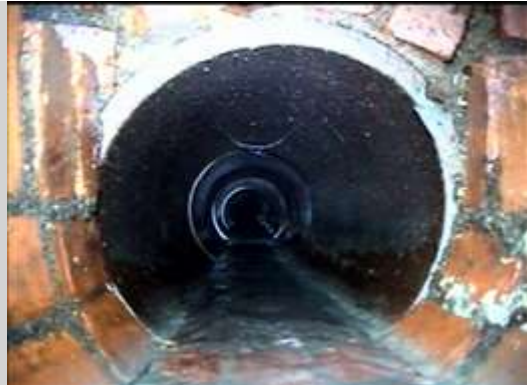
12 O'Clock Outflow

10 in. Circular Gravity Sewer
Pipe Out @ 12 O'Clock

Pipe Height: **12** (in.) Rod and Bar (Angled)
Pipe Material: **Clay** ☐ Pipe Lined
Invert Depth: **15.12** (ft.) Flow Characteristics: **Fast**
Deposits: ☒ None ☐ Mud ☐ Sludge ☐ Debris ☐ Grease
Silt Depth: (in.) Deposits Extent:
Infiltration: **None** Pipe Seal Cond: **Sound**

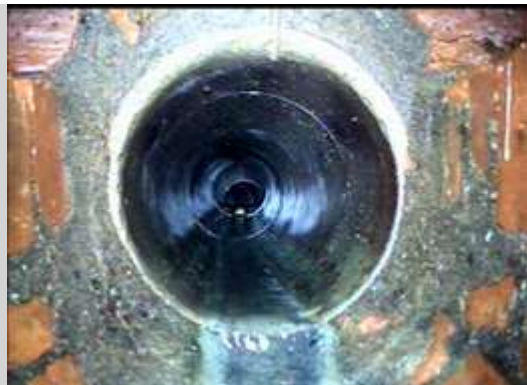
3 O'Clock Inflow

10 in. Circular Gravity Sewer
Pipe In @ 3 O'Clock

Pipe Height: **9.6** (in.) Rod and Bar (Angled)
Pipe Material: **Clay** ☐ Pipe Lined
Invert Depth: **14.81** (ft.) Flow Characteristics: **Slow**
Deposits: ☒ None ☐ Mud ☐ Sludge ☐ Debris ☐ Grease
Silt Depth: (in.) Deposits Extent:
Infiltration: **None** Pipe Seal Cond: **Sound**

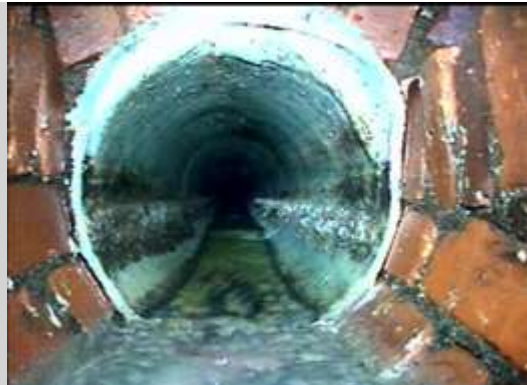
6 O'Clock Inflow

12 in. Circular Gravity Sewer

Pipe In @ 6 O'Clock

Pipe Height: **12** (in.) Rod and Bar (Angled)

Pipe Material: **PVC** ☐ Pipe Lined

Invert Depth: **15.12** (ft.) Flow Characteristics: **Fast**

Deposits: ☒ None ☐ Mud ☐ Sludge ☐ Debris ☐ Grease

Infiltration: **None** Pipe Seal Cond: **Sound**

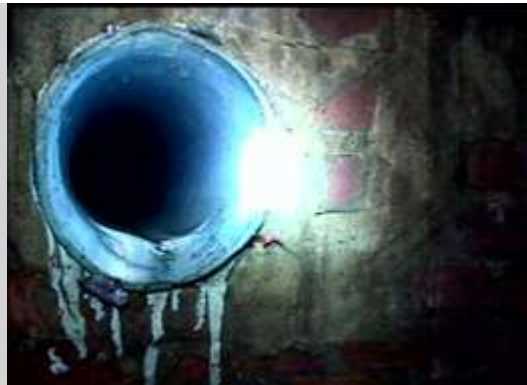
9 O'Clock Inflow

10 in. Circular Gravity Sewer

Pipe In @ 9 O'Clock

Pipe Height: **9.6** (in.) Rod and Bar (Angled)

Pipe Material: **Clay** ☐ Pipe Lined

Invert Depth: **10.53** (ft.) Flow Characteristics: **Slow**

Deposits: ☒ None ☐ Mud ☐ Sludge ☐ Debris ☐ Grease

Infiltration: **None** Pipe Seal Cond: **Sound**

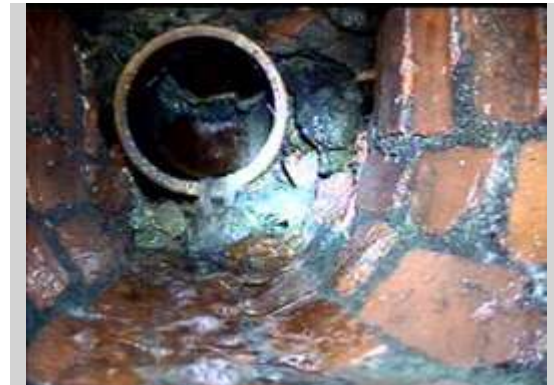
Drop In @ 9 O'Clock

Drop: **Outside Direct**

Inv Depth: **13.93** (ft.)

Drop Condition: **Open**
